Preliminary Report

**Sioux Silo Failure Investigation
Tepic, Mexico.**

**ESI Project: 47623T
AIG Claim: NX0008863
PP REF.: 12465**

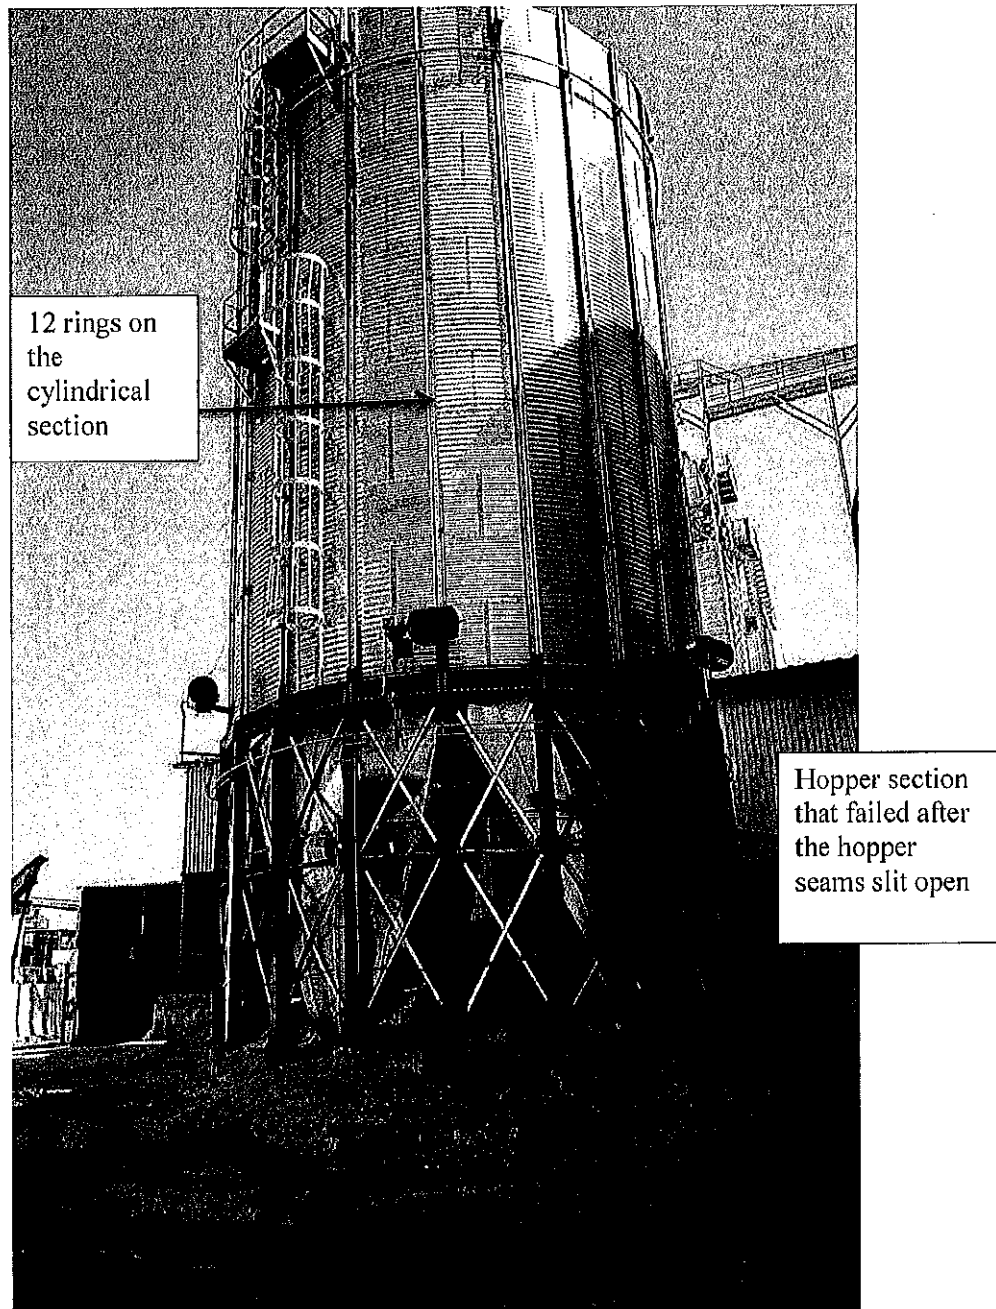
Fig. 1: View of the 30' diameter Sioux failed silo.

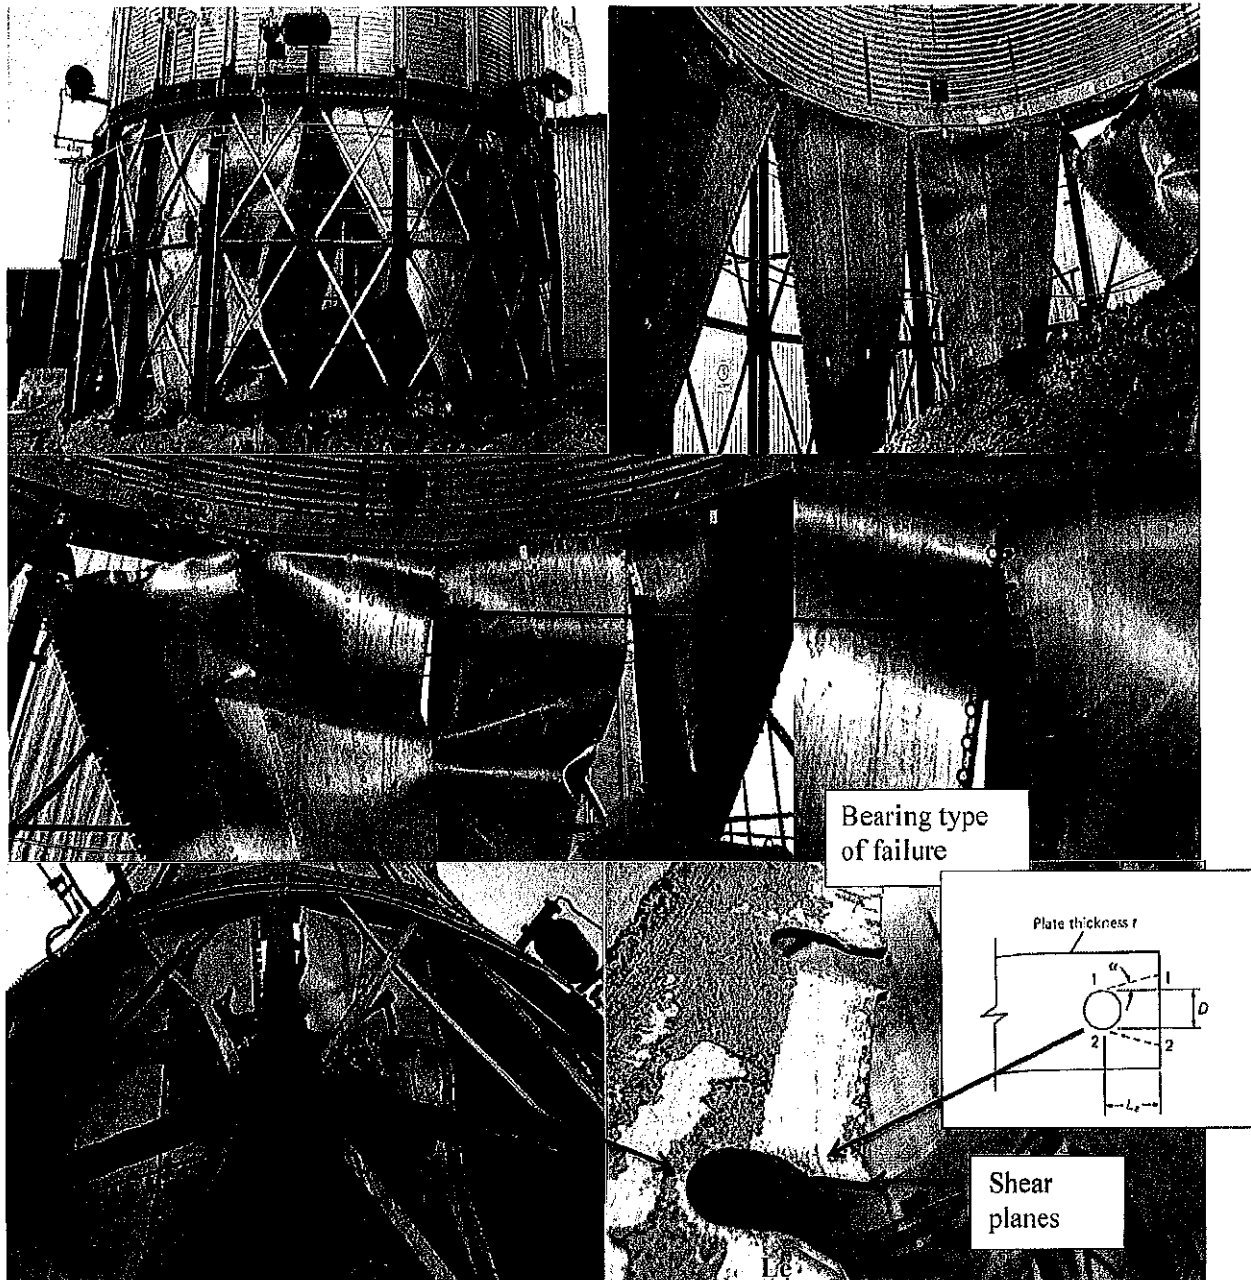
After examining the failed hopper, it could be corroborated that the hopper shell split open at the seams (see Fig. 5). As can be observed from the pictures of Fig. 5, it is evident that some fasteners used to attach together the hopper laminates tore through the ends of the laminates' edges causing a bearing type of failure of the bolted joint due to shear stresses (on the laminate edges). Therefore, it is clear that hoop stresses (or circumferential stresses) acting perpendicular to the seams, pulled those seams apart and then caused the failure of some bolted joints at those seams of the hopper. Following are the circumstances that led to that failure.

Fig. 5: Photo of the hopper failure.

- It could be corroborated that the root cause of the failure of the hopper section of the referenced silo was that the hopper shell split open at the seams. It is evident that some fasteners that were used to attach the hopper laminates together, tore through the ends of the laminates' edges causing a bearing type of failure of the bolted joint due to shear stresses (on the laminate edges).

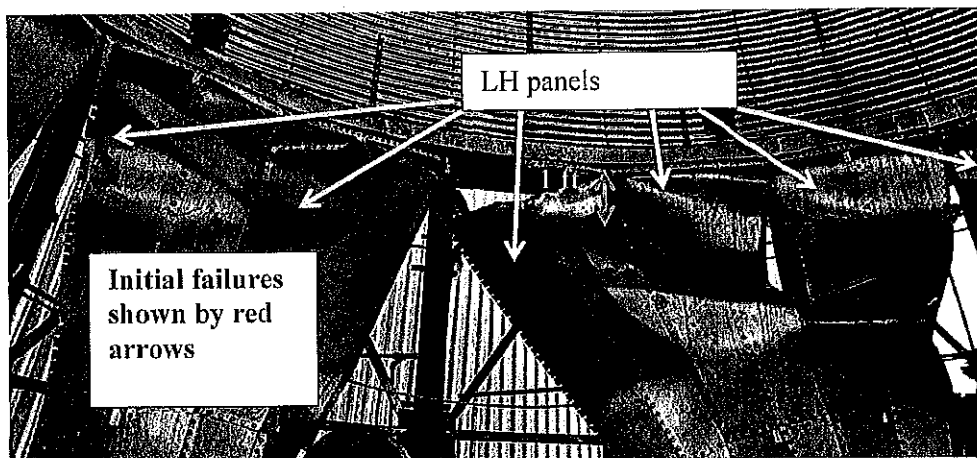
If we included that overpressure effect on the values obtained in Table 3, then the values shown in Table 4 would be obtained. Based on the results shown in Table 4 it is evident that a seam failure would have occurred as the 'Upper LH' panels or laminates had a distance 'Le' of 0.719 inches and the minimum required 'Le', for preventing the bearing failure at the bolted joints at the seams at a location just below the cone, would be greater than that after the emptying process had started.

The majority of the panels, where their edges failed, were the 'LH' type and the failures started at about 1 ft. below the top of the hopper cone (see Fig. 11). After one of the bolted joints failed at each seam then the adjacent joints were not able to resist the extra stresses conveyed to them and a chain reaction type of failure occurred all the way down the seams from the initially failed joint.

Fig. 11: 'Upper LP' Panels failure.

- The majority of the panels, where edges failed, were the 'LH' type and the failures started at about 1 ft. below the top of the hopper cone (see Fig. 11). After one of the bolted joints failed at each seam the adjacent joints were not able to resist the extra stresses conveyed to them and a chain reaction type of failure occurred all the way down the seams from the initially failed joint.

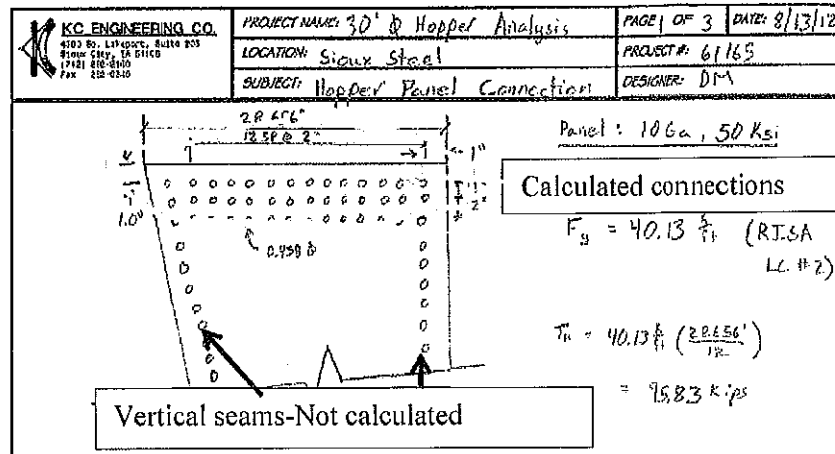
ESI was provided with the engineering and structural analysis for the referenced Sioux-30' diameter hopper type silo performed by 'KC Engineering' (hereinafter KC) located in Sioux City, Iowa. From the document provided to ESI we could verify that this engineering analysis did not consider or include any calculation for the bolted connections of the vertical seams of the hopper. The only connections that were calculated by KC were the top connections of the hopper with the ring of the bottom of the cylinder of the silo (see Fig. 14).

Fig. 14: Hopper panel connection calculations from KC.

The lack of the consideration for or the overlooking of the hoop stresses effect on the bolted connections of the silo hopper seams in the structural analysis performed by KC can be considered as a serious engineering oversight; an oversight that actually was the principal cause of the failure of this hopper silo. In an engineering analysis of this importance and level in which individuals' lives can be in jeopardy, it is mandatory to check all the structural members of the structure, such as the bolted connections
